**County of Maui Parks Department**  
ATTN: Patrick McCall & Shane Dudoit

January 15, 2024

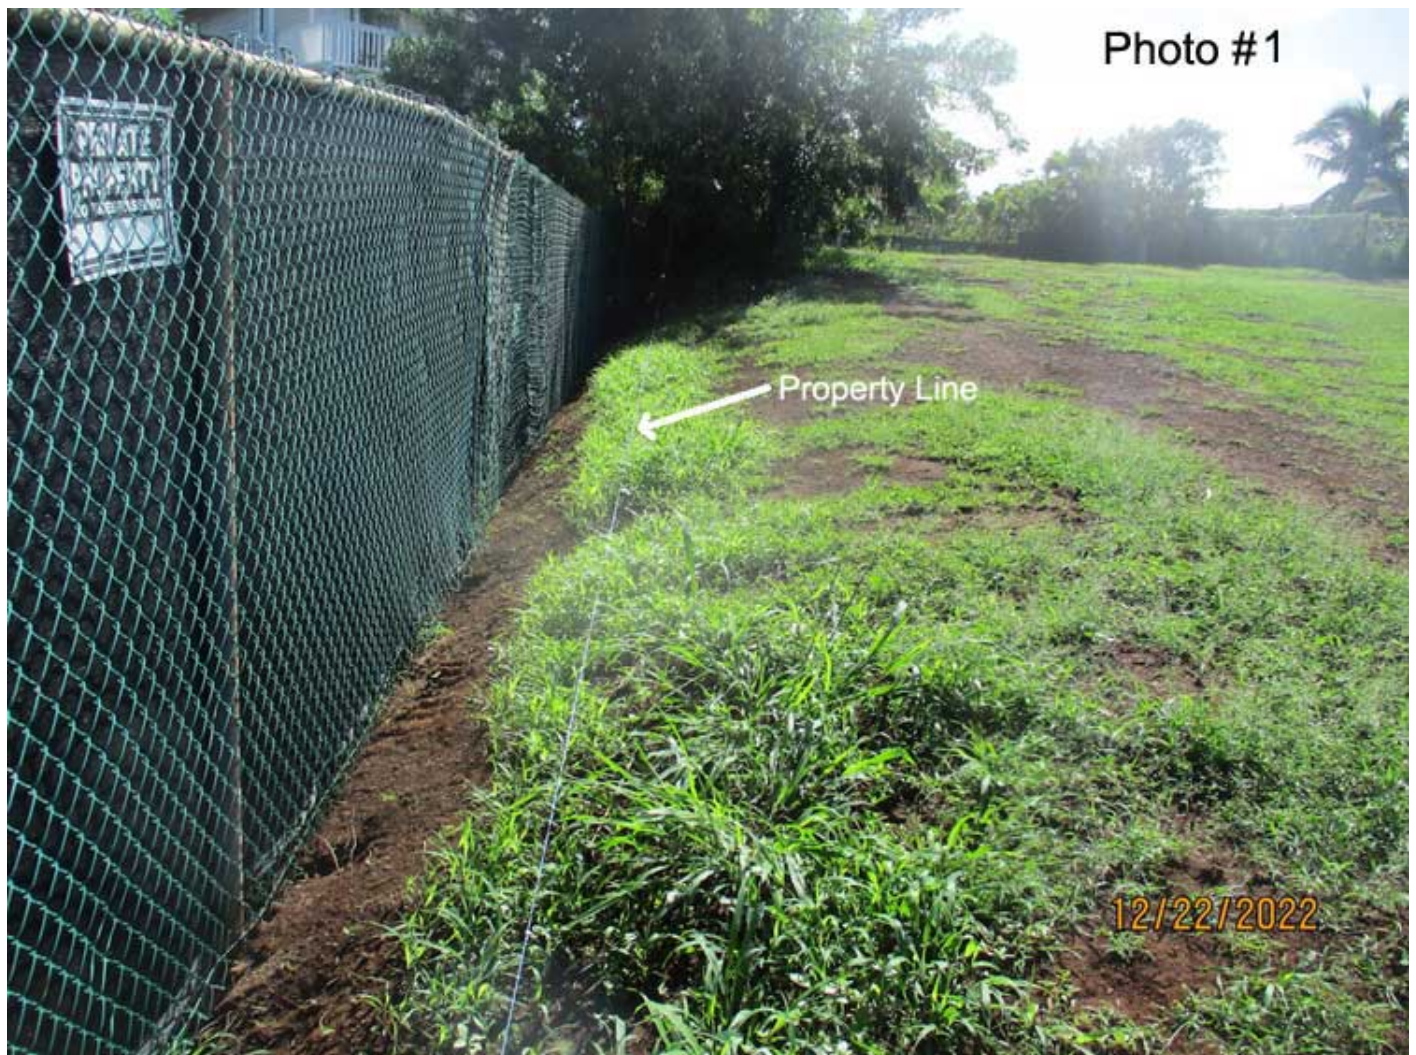
Aloha, Based on the photos, it looks like in some areas of the fence line, we are unable to perform any repairs due to the steep incline and unable to safely perform the work to insure proper installation. It also looks like the fencing in some areas is buried due to backfill and will require that the back filled soil that has buried the fencing, be pulled away from the fencing which the fencing is retaining.

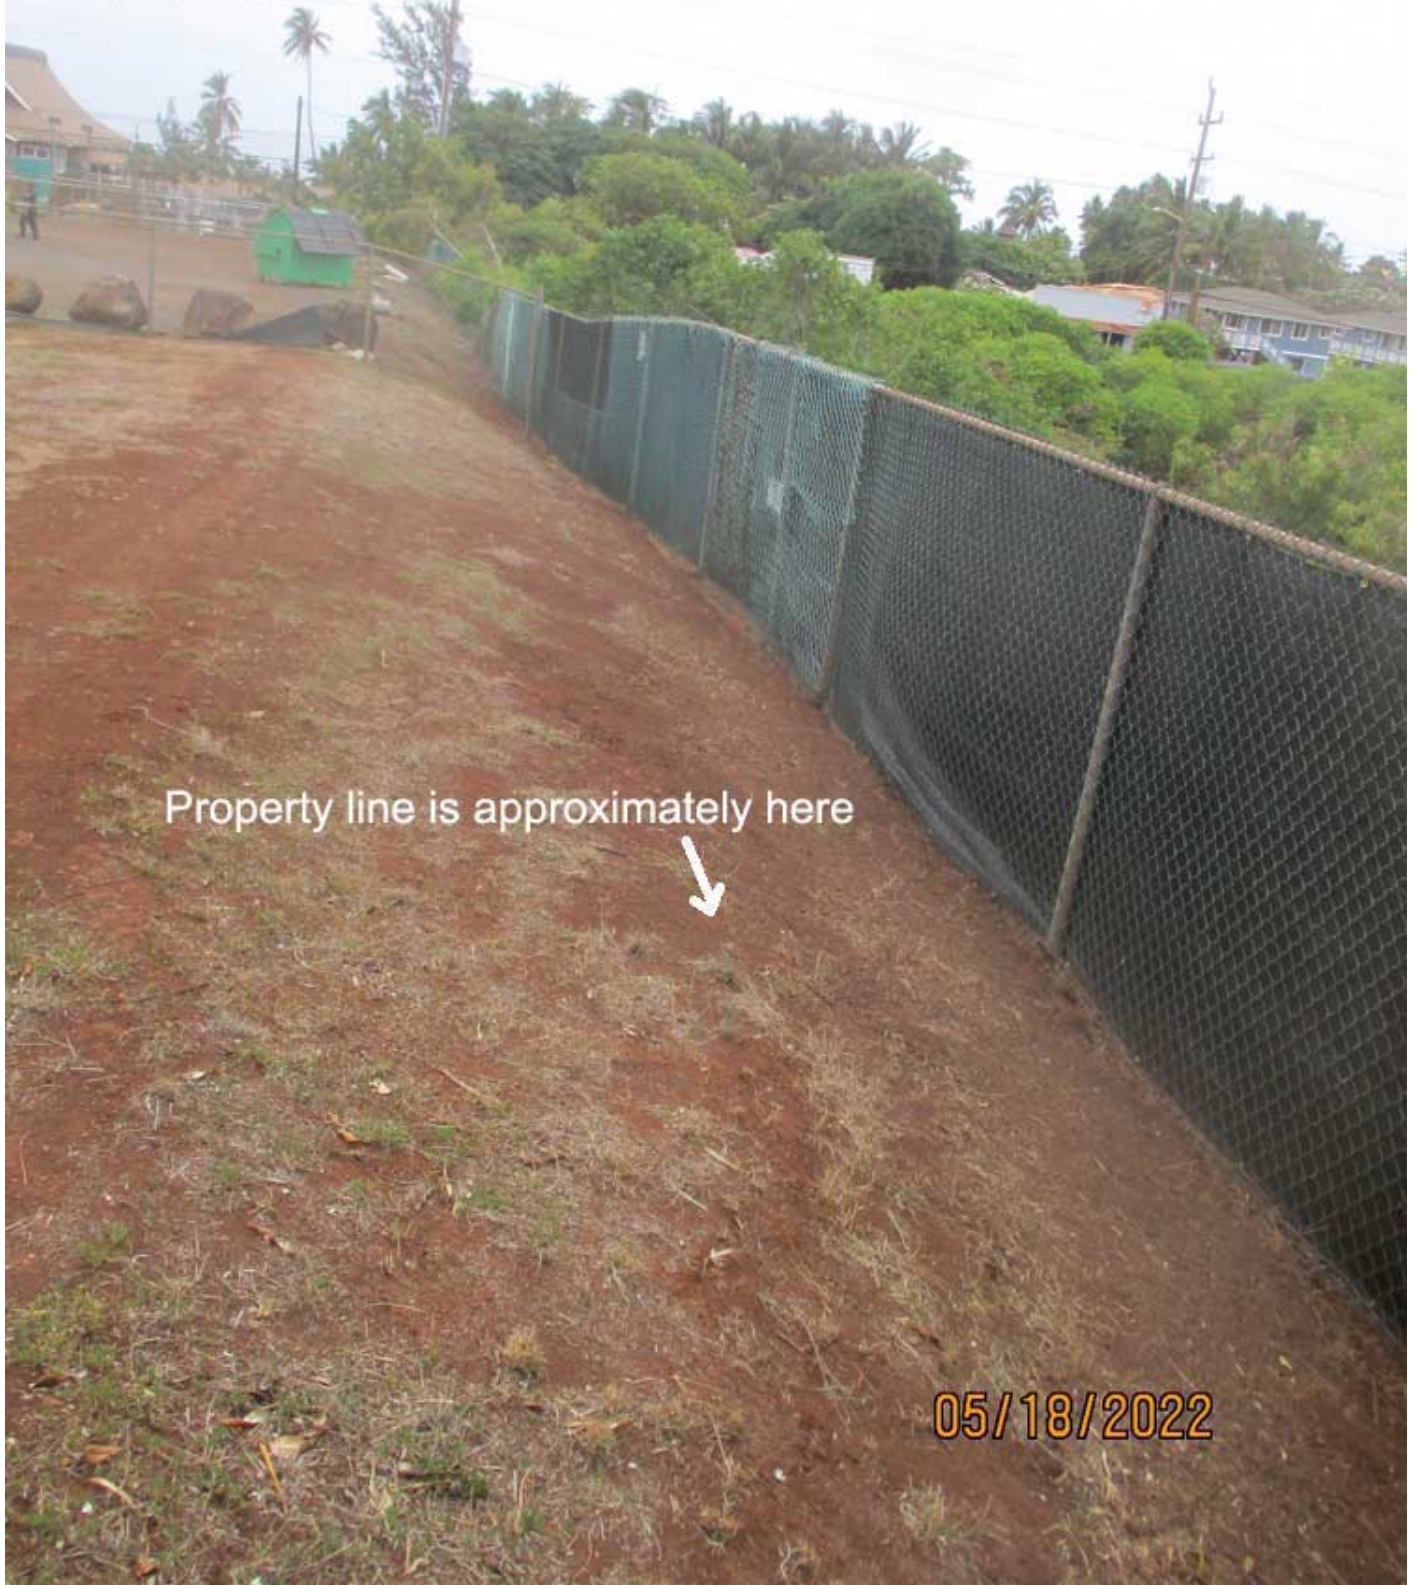
Over 3 feet of fill was deposited which had to be 2 feet from the property line but went over the line and onto HOA property. We need this removed and the flat area restored.

Property line is approximately here

In order to make it possible for the HOA to erect the new fence, we must demand that you immediately remedy the grading violations that Parks committed and still exist on HOA property. When A&B originally erected the fence around the Retention Basin in 1996, they positioned the fence from 2 to 4 feet inside the property line on the flat ground at the top of the basin slope. Tom & I spent hours measuring and marking the property line, but feel free to do your own marking. The property pins are located at the corner of Lot 26 under the Shower tree, and at the base of the rock wall along Hana Hwy below the telephone pole. We will be erecting the new fence along our side of the property line as soon as the ground level has been restored. Once your fill has been removed, there will be a flat area extending from the existing fence to two feet on the PCC side of the property line enabling installation of the new fence. Observe the fill violation in Photo #2 on page 3. Photo #1 shows the property line as marked on Dec 22, 2022. Parks erroneously assumed that all land on the PCC side of the Retention Basin fence was part of Lot 25, which is not true. The HOA is reclaiming its land and asks Parks to cease and desist from dumping fill, cement, or anything else on HOA property. The exact boundary will be more evident when the fence is positioned along the property line and all violations are corrected. Below is the ordinance pertaining to cut or fill slopes...

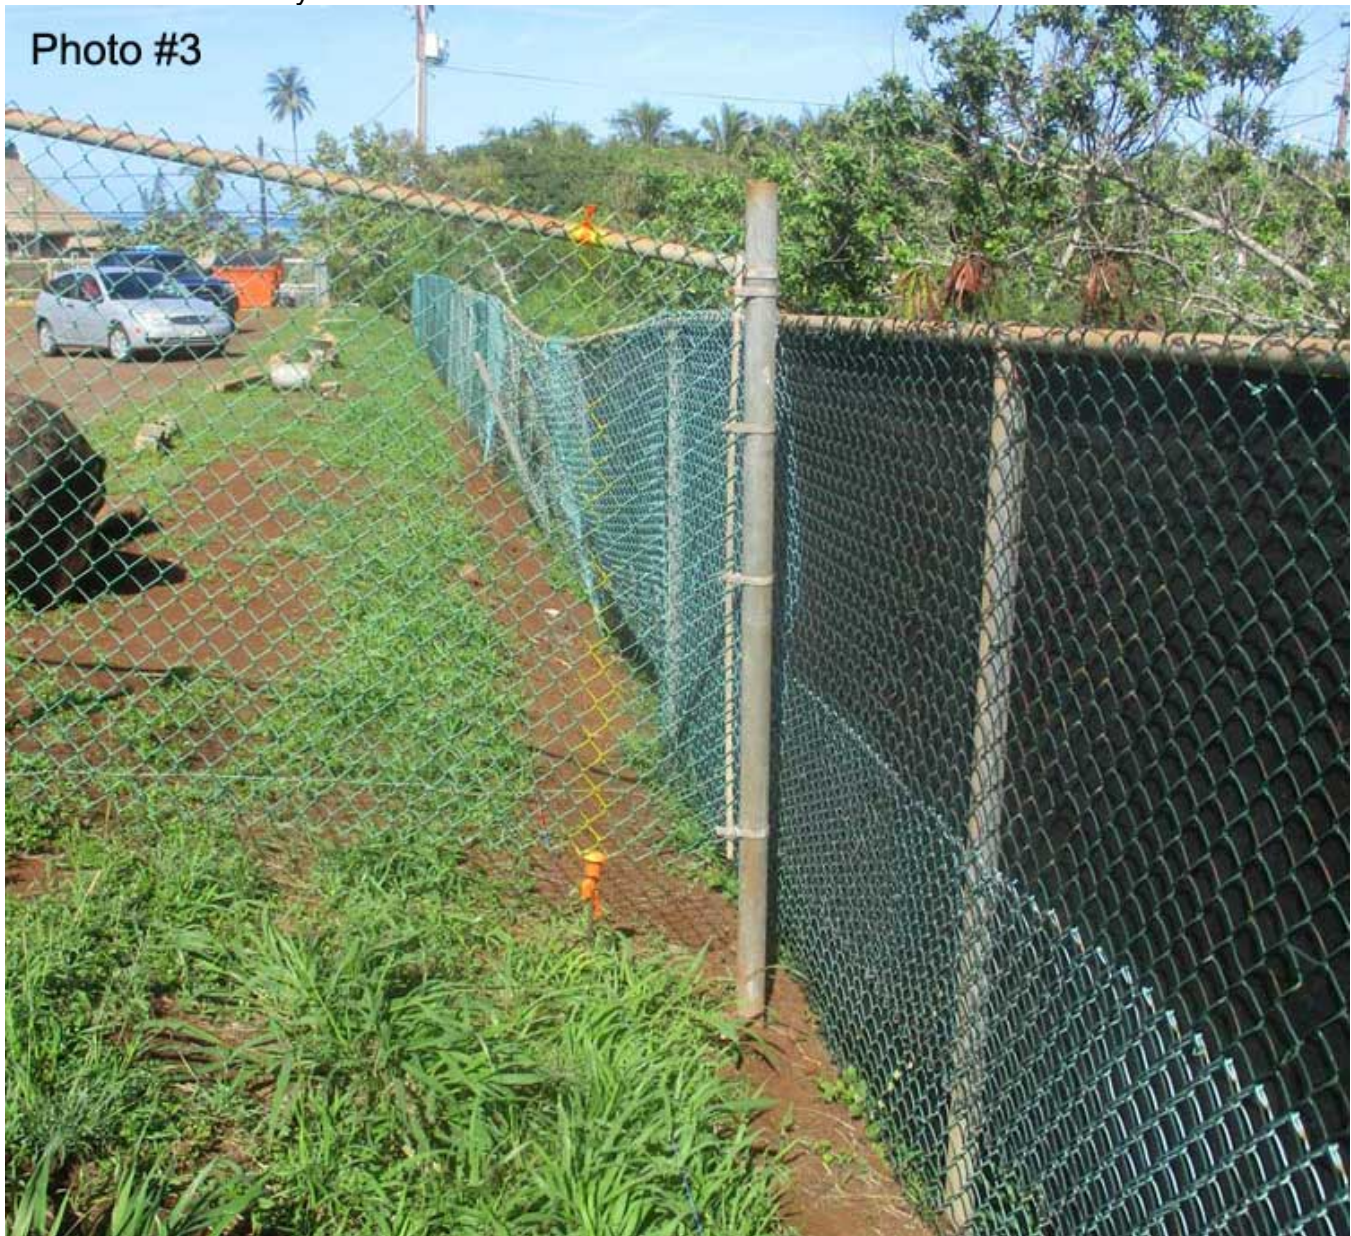
Secondly, please immediately remove the Park fence post, cement, and fencing that was installed on HOA property as shown in Photo #3 below. Besides transecting the new HOA fence line, this end of the Park fence will have to be removed in order to remedy the fill violation. It will be much better when proper, lawful respect is accorded to the boundary between the Paia Community Center and Kuau Bayview at Paia subdivision land.
